Manhole Inspection Summary

Manhole # S25SS1003MH

Inspection ☐ Is Incomplete Rating: **4) Poor**

Location Address: **CARLOWE RD**

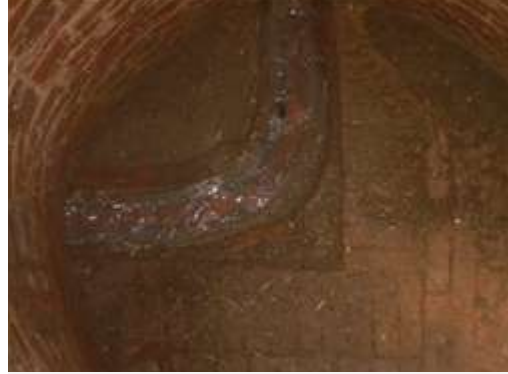
Top View

Bench ☒ Exists Material: **Brick** ☐ Parged ☒ **Debris** (not Condition related)

Bench debris.

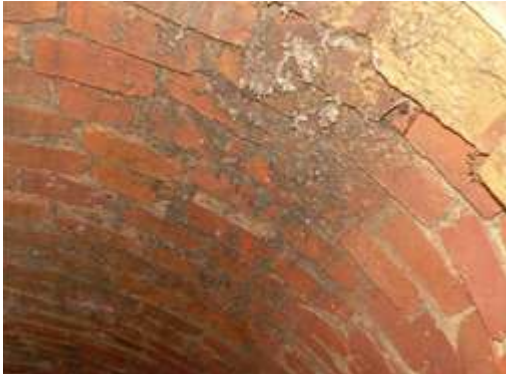
Defect

Infiltration: ☐ None ☒ **Joint** ☐ Cracks ☐ Mortar ☐ Roots ☐ Wall

Corbel infiltration.

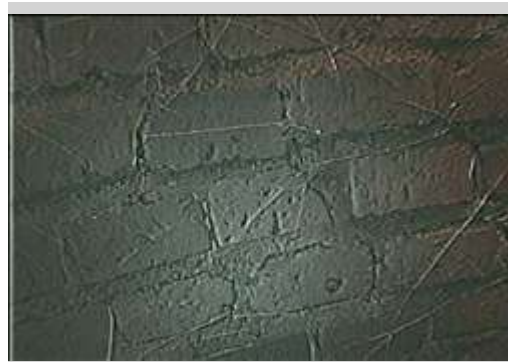
Defect

Condition: ☐ Sound ☐ Cracked ☒ **Root Intrusion** ☐ Loose Brick ☒ **Deteriorated**

Infiltration: ☐ None ☐ Joint ☐ Cracks ☒ **Mortar** ☒ **Roots** ☒ **Wall**

Barrel deterioration, root intrusion and infiltration.

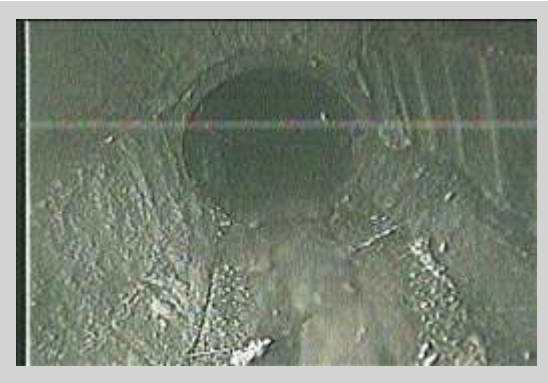
8 in. Circular Gravity Sewer Pipe Out @ 12 O'Clock

Barrel deterioration and infiltration. Channel deterioration.

Infiltration: **Evidence** Pipe Seal Cond: **Cracked**

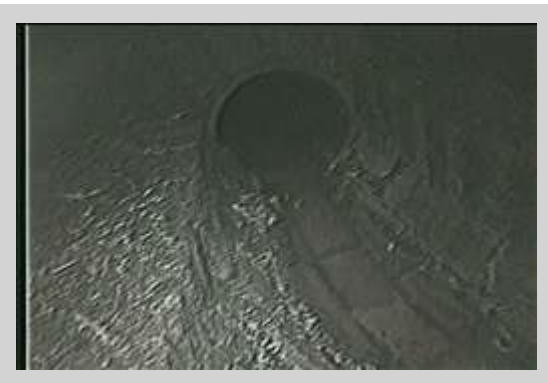
8 in. Circular Gravity Sewer Pipe In @ 9 O'Clock

Barrel deterioration and infiltration. Channel deterioration.
